XPCamper #14 Sale Document

Truck Details – (Appendix A)	
Vehicle Type	Pickup Truck, XP Built Flatbed Tray, and XP Lift top camper
Make/Model of Truck	Dodge Ram 3500 SLT Quad Cab 5.9L Cummins Diesel
Year of Truck	2007
VIN of Truck	3D7MX38C77G703782
Mileage	122,xxx (will increase from occasional use)

Camper/Tray Details – (Appendix B)	
Make/Model of Camper/Tray	XPCamper V1 Hydraulic
Year of Camper/Tray	2015
Sr. No of Camper/Tray	XPV1014PR11092014

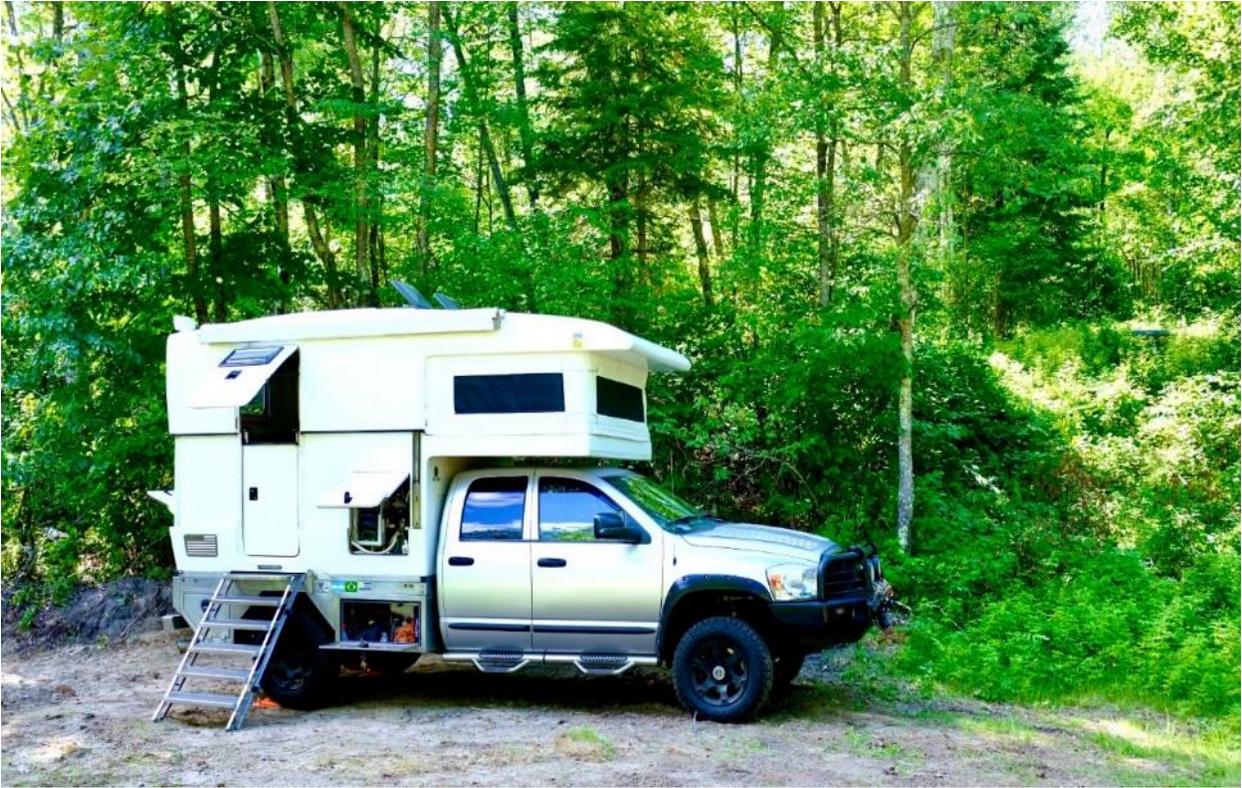
Figure 1: Lifting Top Deployed

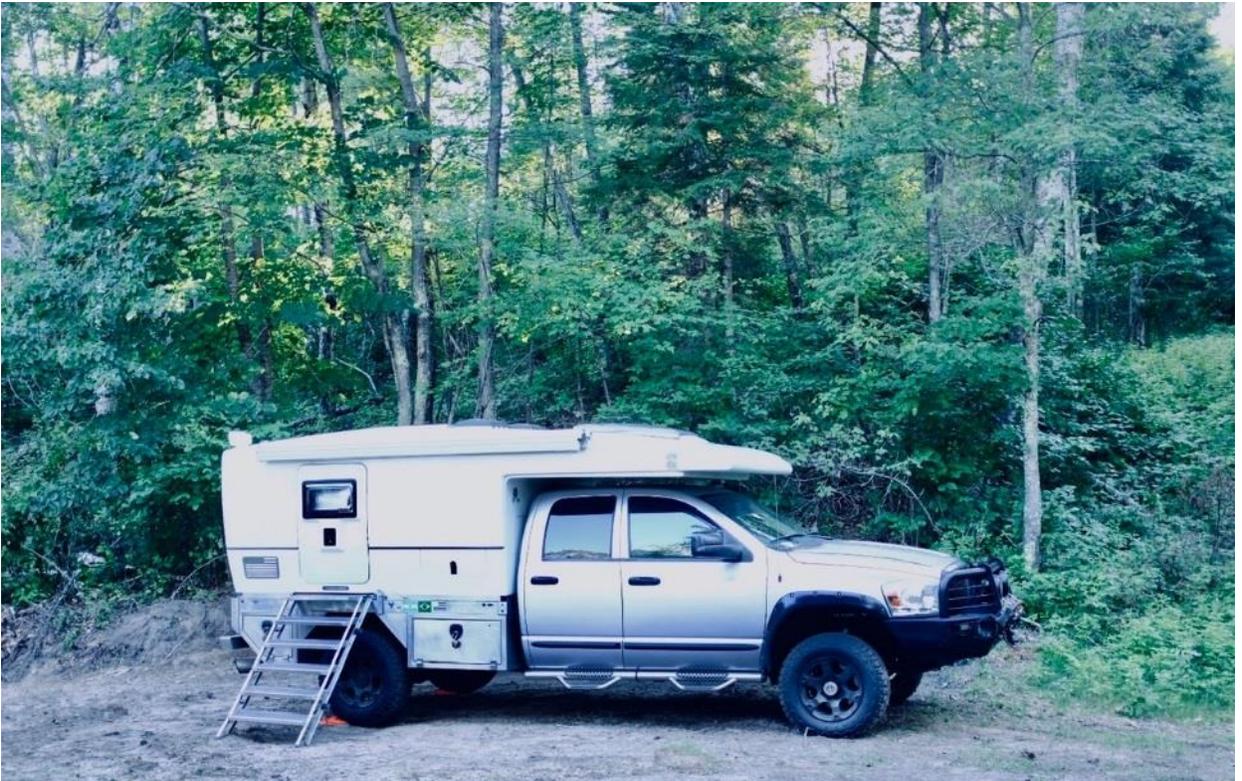
Figure 2 Lifting Top Lowered for Travel

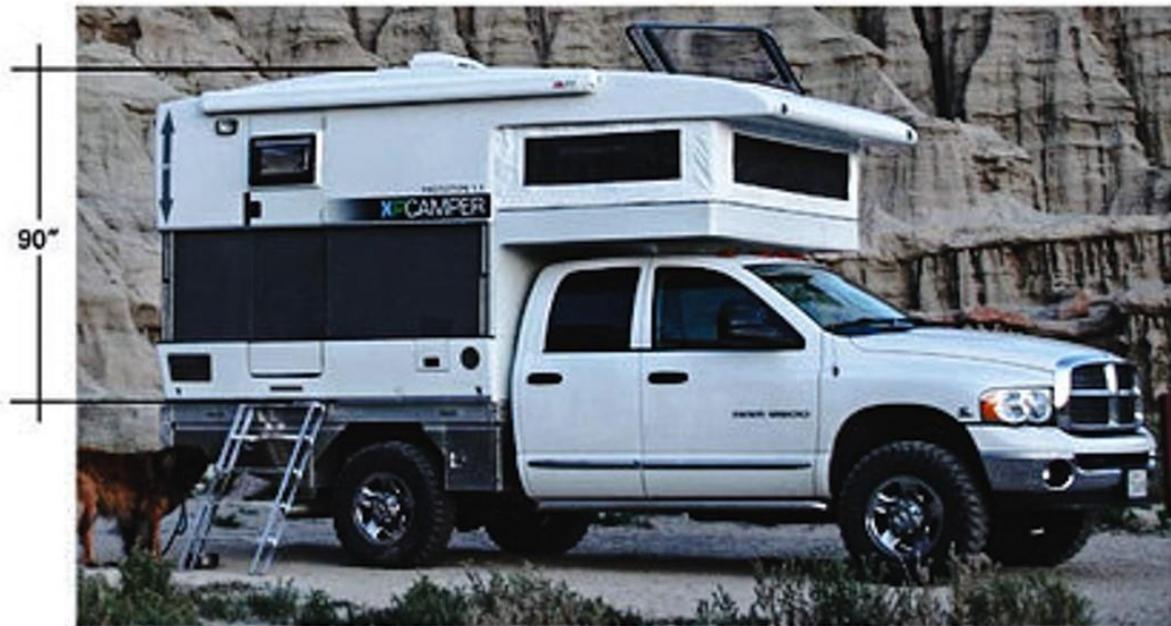
Figure 3 Representative Dimensions of XPCamper (not my camper)

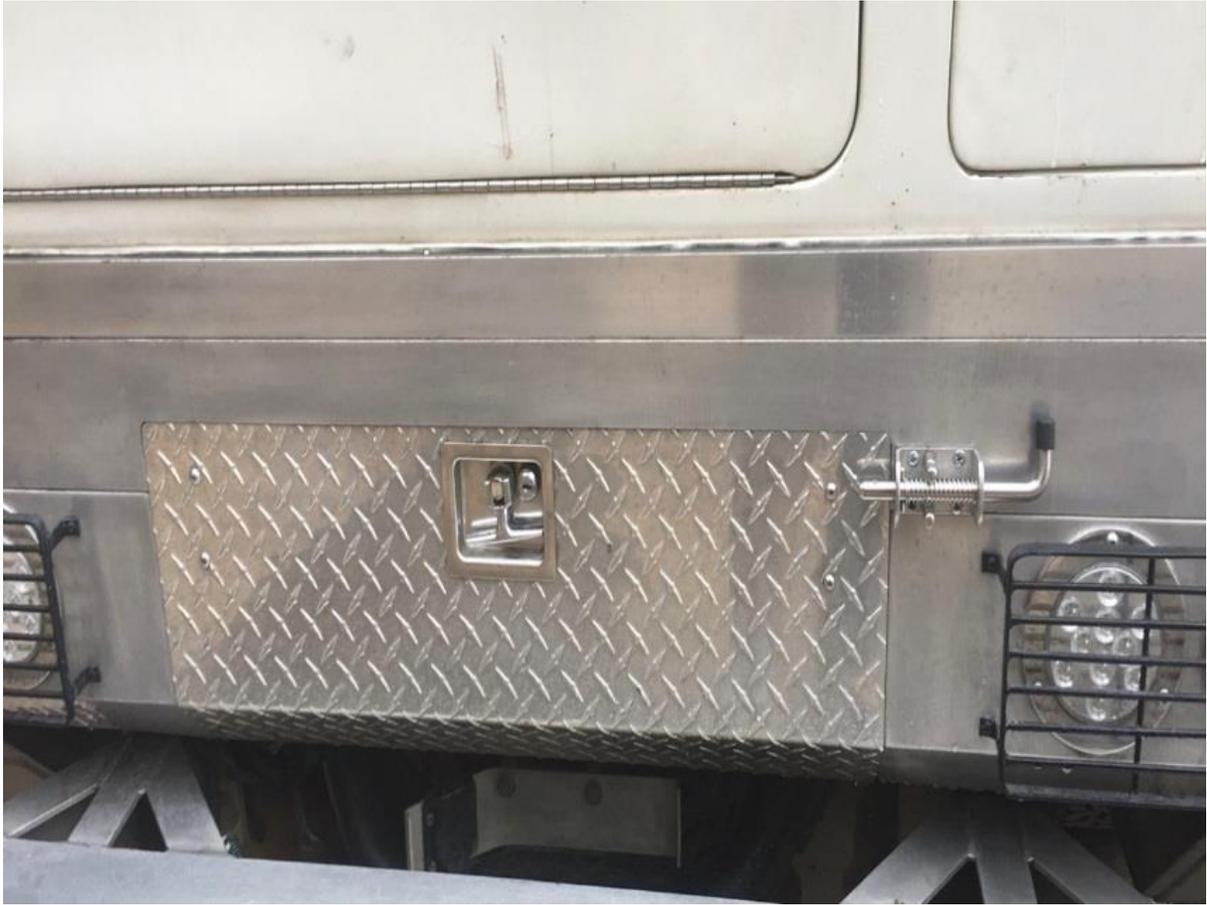
Figure 4 Rear Basement Garage and Kitchen

- Large pullout “basement” tray. This is a five foot long pullout tray built into the rear of the flatbed. This currently holds the Chef Partner propane stove, propane cylinder, spare tire crank, awning crank, and various odds and ends. It can also hold two MaxTrax recovery boards if one elects to not use the external mounted L-Track.

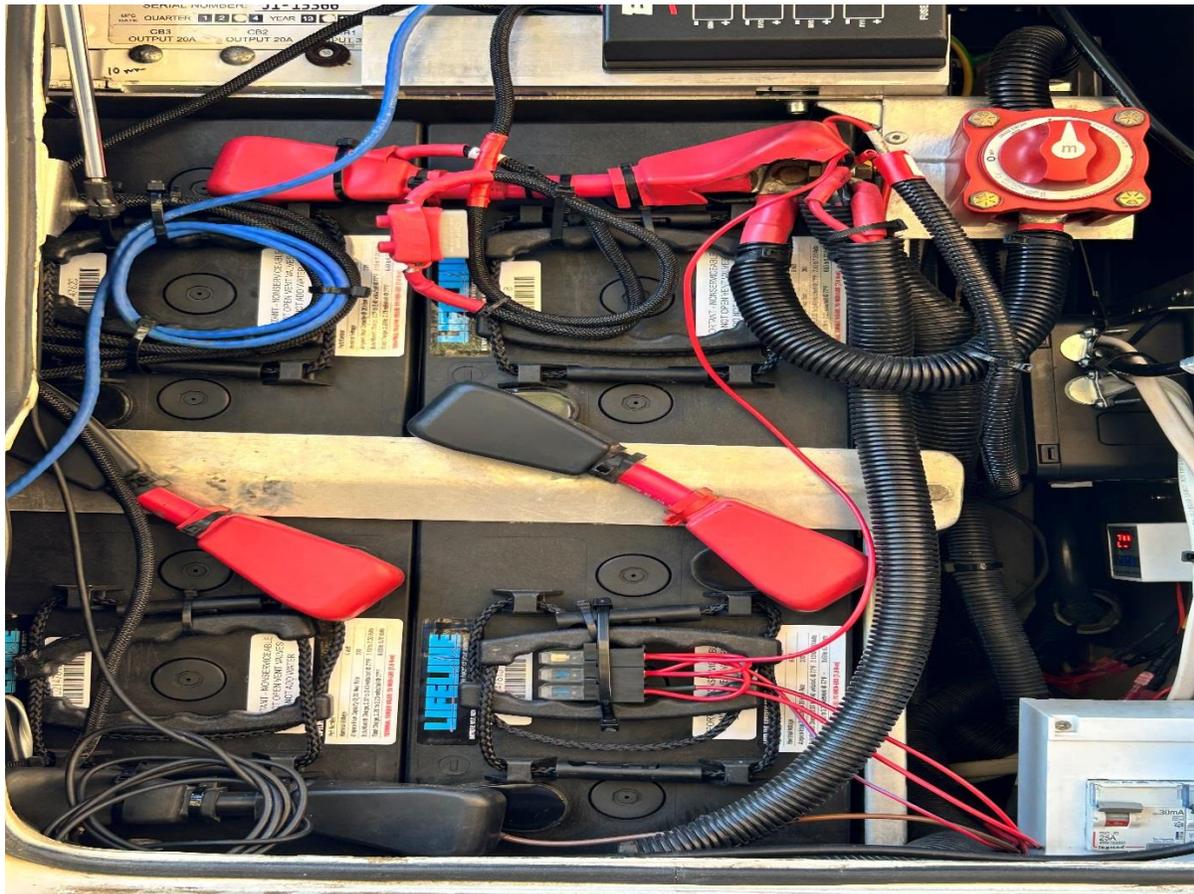
Figure 6 House AGM Battery Bank

- 4 Flex solar panels @ 160W ea. 640 Watts of Solar panels on roof
- New in 2023 - Original PWM solar charge controller replaced with Victron 100/50 MPPT charge controller. Work done by Titan Vans Boulder
- New in 2022 – 4 Lifeline 6V/300AH AGM batteries for a total of 12V/600AH battery capacity. Work done by The Shop Automotive Boulder
- Magnum Pure Sine Inverter 2000w 12V with BMS
- New in 2022 - AC load management module added in electrical bay to priority load balance between microwave and induction cooktop
- New in 2021 – 120VAC/USB outlet added on side of galley cabinet for charging phones at night
- New in 2023 - Galley countertop 120VAC and USB outlets installed
- 120VAC and 12V outlets in dinette area under the seats

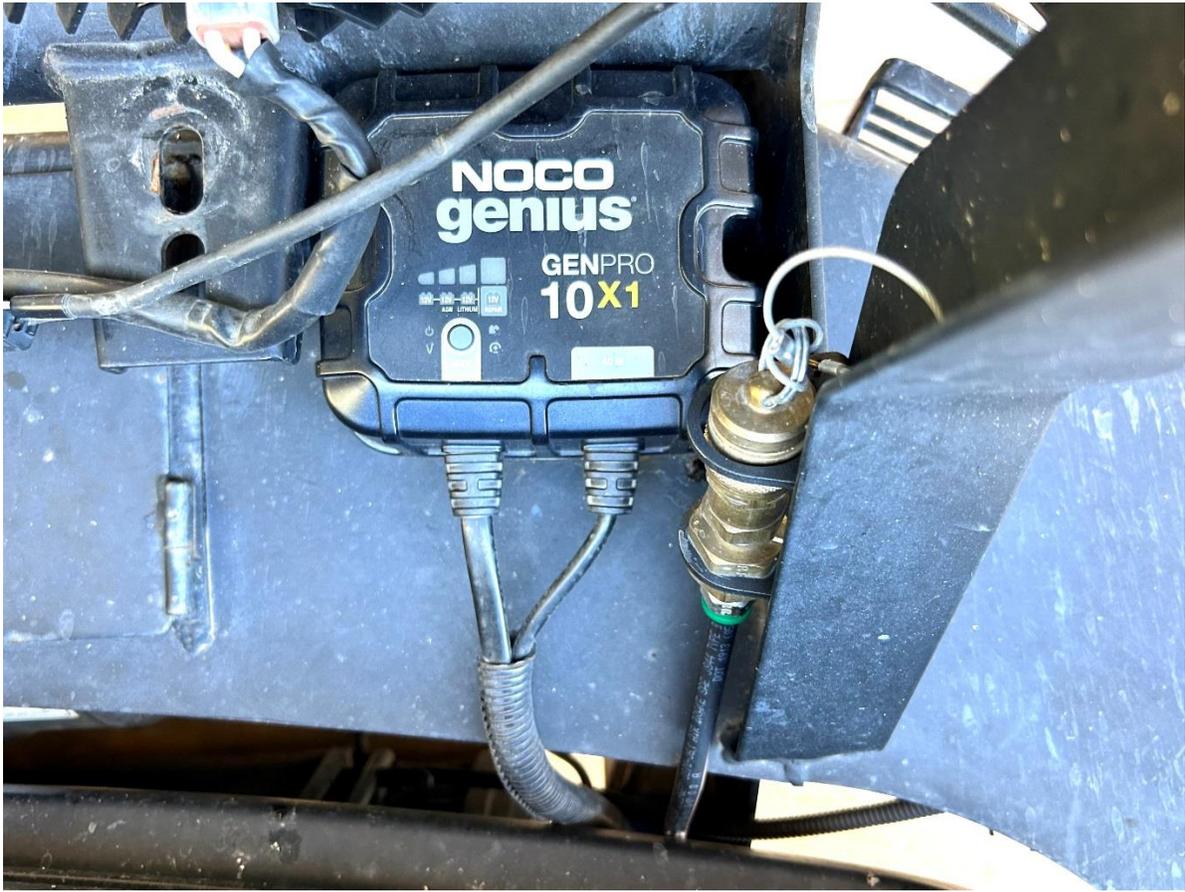
Figure 7 Bumper Mounted Trickle Charger

- New in 2023: Driver's side rear wheel and tire
- New in 2022: AC inputs mounted in front bumper for the engine block heater and a NoCo trickle charger for starter batteries

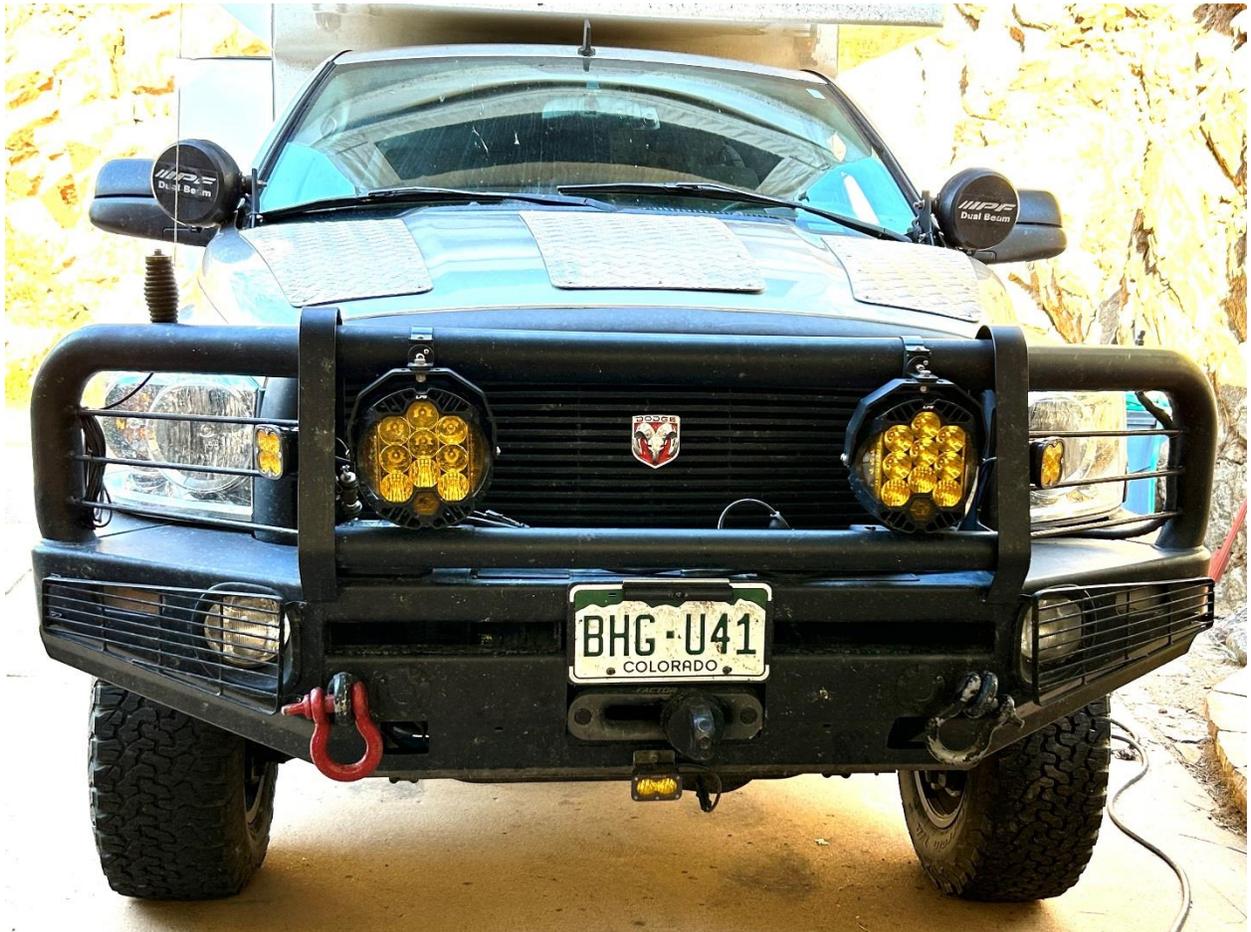
Figure 13 Front Winch Bumper and Lights

- New in 2020 - Jake Brake
- ARB Front Winch Bumper
- WARN Winch 16.5ti with synthetic rope. Wired remote included. Bluetooth module added for control by phone. Blue Sea manual disconnect switch added along with forward Baja Designs under bumper light which comes on when the Blue Sea disconnect is turned on. The Blue Sea disconnect was added in 2020 to eliminate any risk of an electrical fire in the event of a front impact which could compromise the high current winch wiring

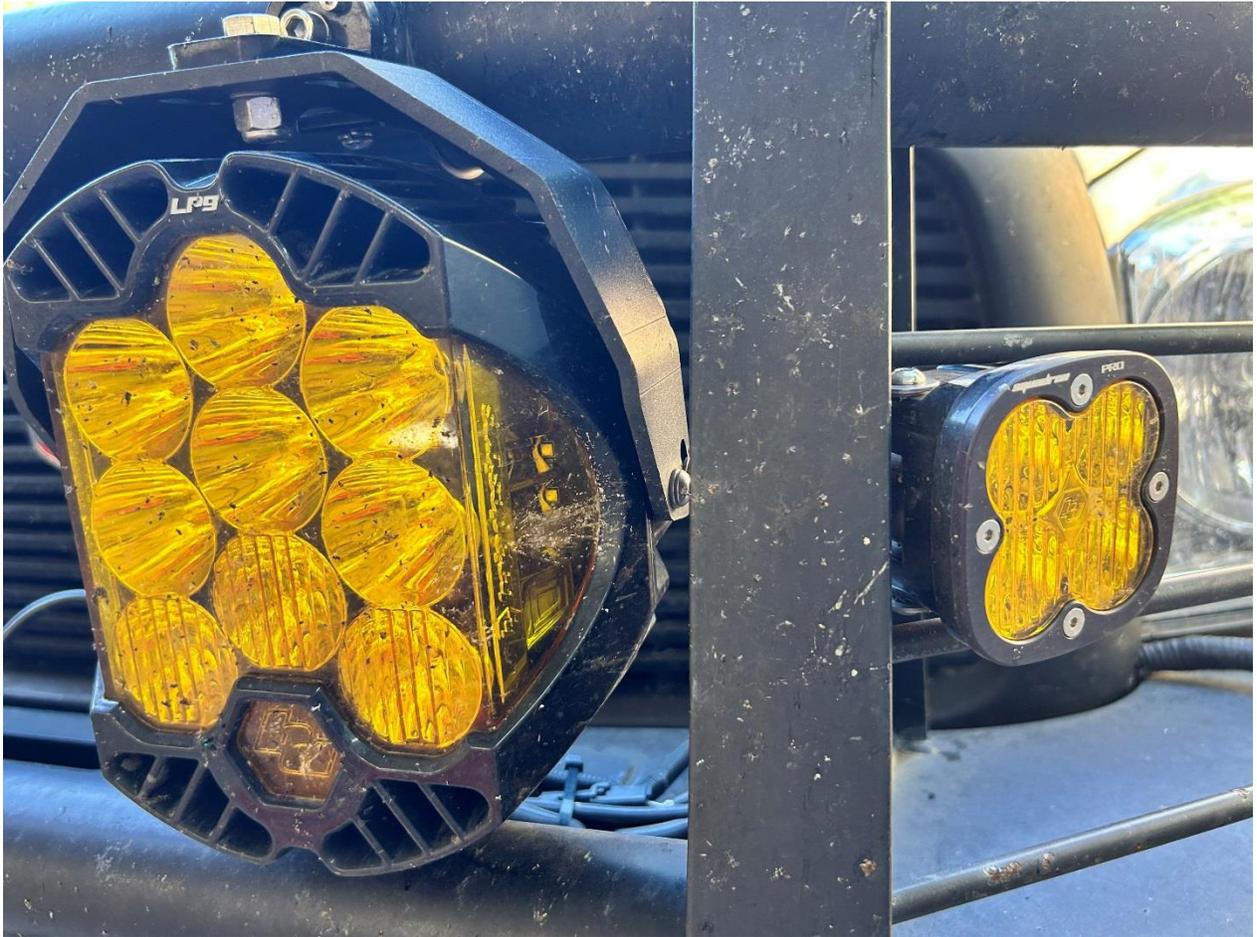
Figure 14 Driver Side Baja Design LP9 and Squadron Pro

- Truck headlights were completely replaced by Dodge in 2020. Led bulbs from Headlight Experts were installed in 2023
- Front bumper has Baja Design Amber LP9s with dual pattern lenses. Clear lenses will be provided if I can find them.
- Baja Design S2Pros installed on Front Bumper as cornering lights
- IPF 900 Dual Beam lights with 110/80 watt bulbs installed on A-Pillars as ditch lights
- Baja Design S2 Sport amber installed under front bumper to indicate when winch circuit is live and serve as winch assistance
- Two Baja Design S2s installed under rear bumper to assist in reversing and parking
- Two Golights on roof with remote controls. The Pan functions work. The tilt functions do not work
- All external lights mentioned are controlled by the sPOD touch screen in the cabin and a secondary touch screen in cabin on galley upper cabinet
- Marker lights around perimeter of flatbed

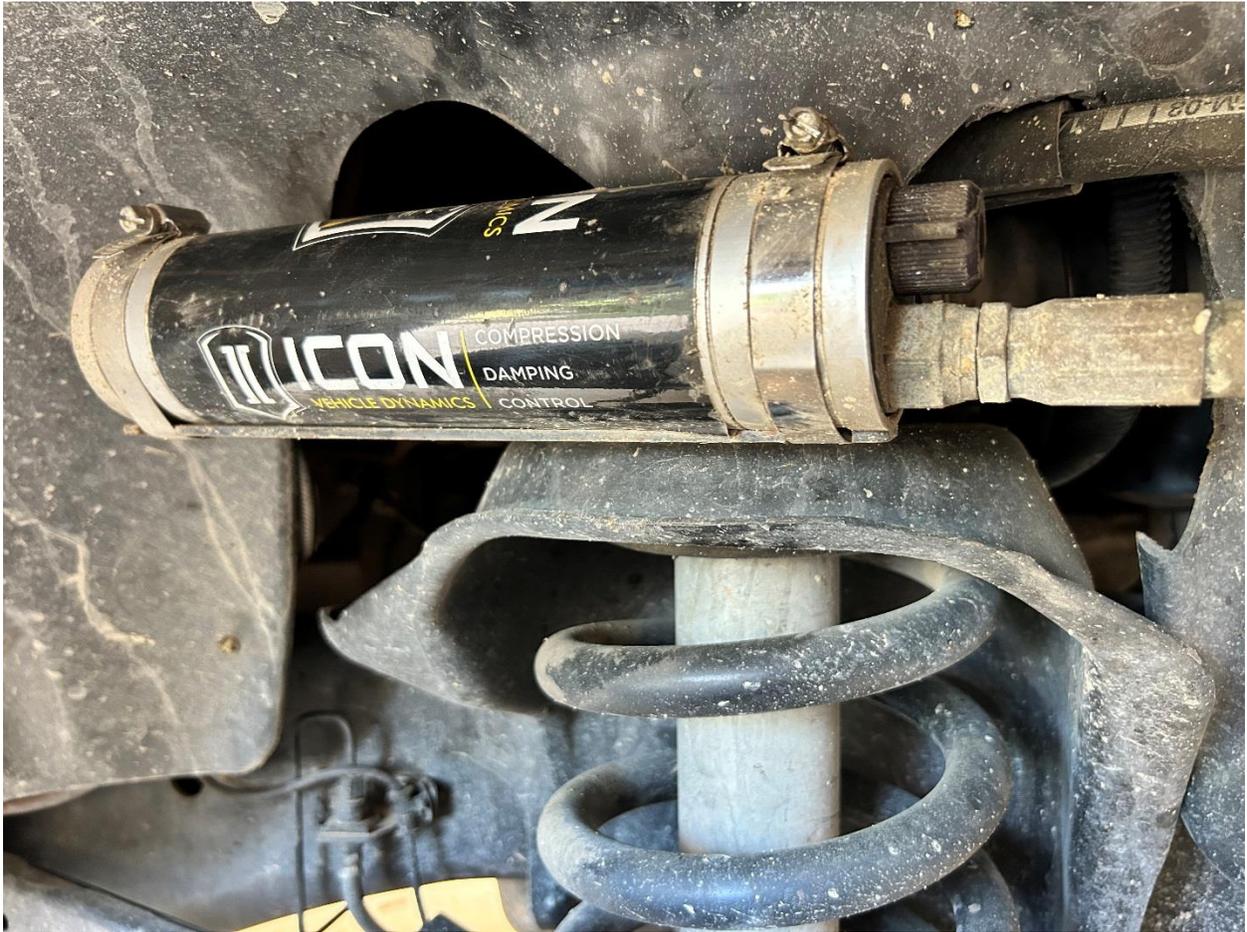
Figure 15 Front Remote Reservoir Custom Icons

- New in 2020 – Adjustable Remote reservoir Icons with custom valving for weight of rig installed by The Shop Automotive in Boulder
- New in 2020 – Full set of weight matched rear leaf springs designed installed by Rocky Mountain Spring in Colorado Springs

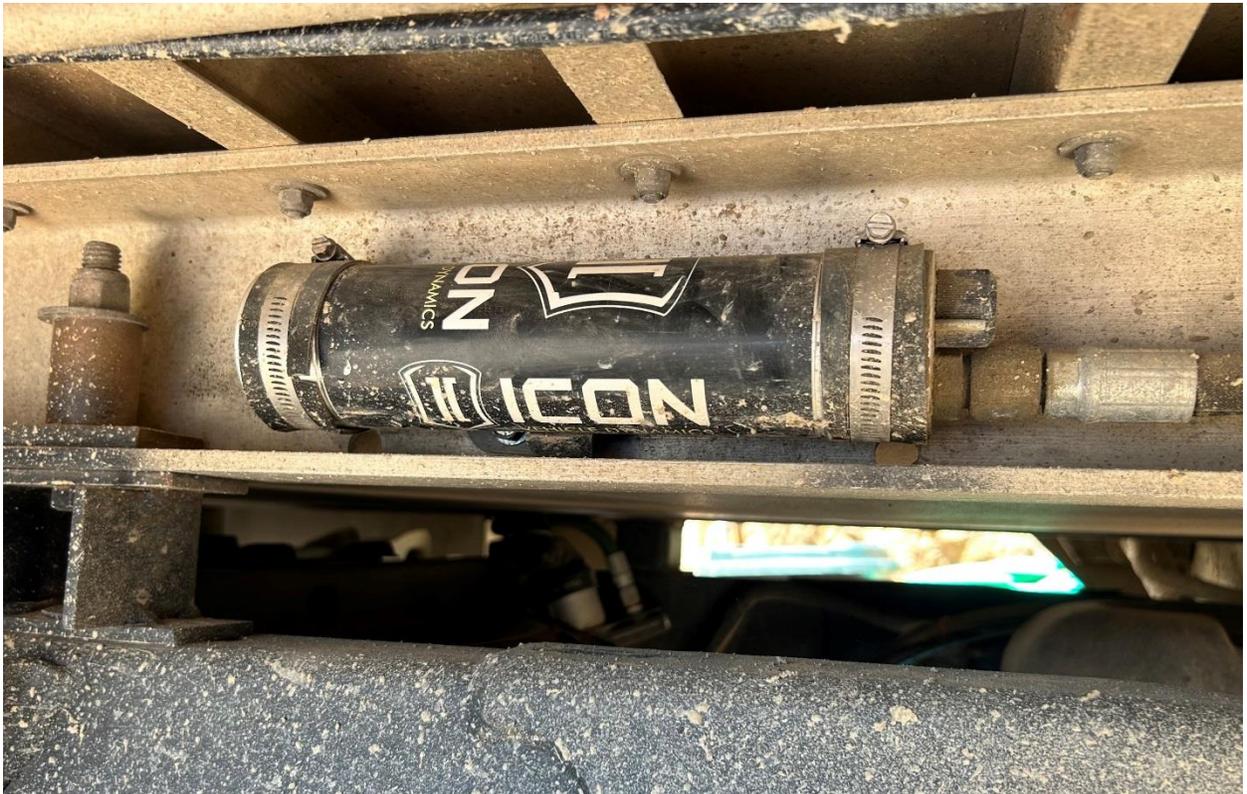
Figure 15: Rear Remote Reservoir Icons

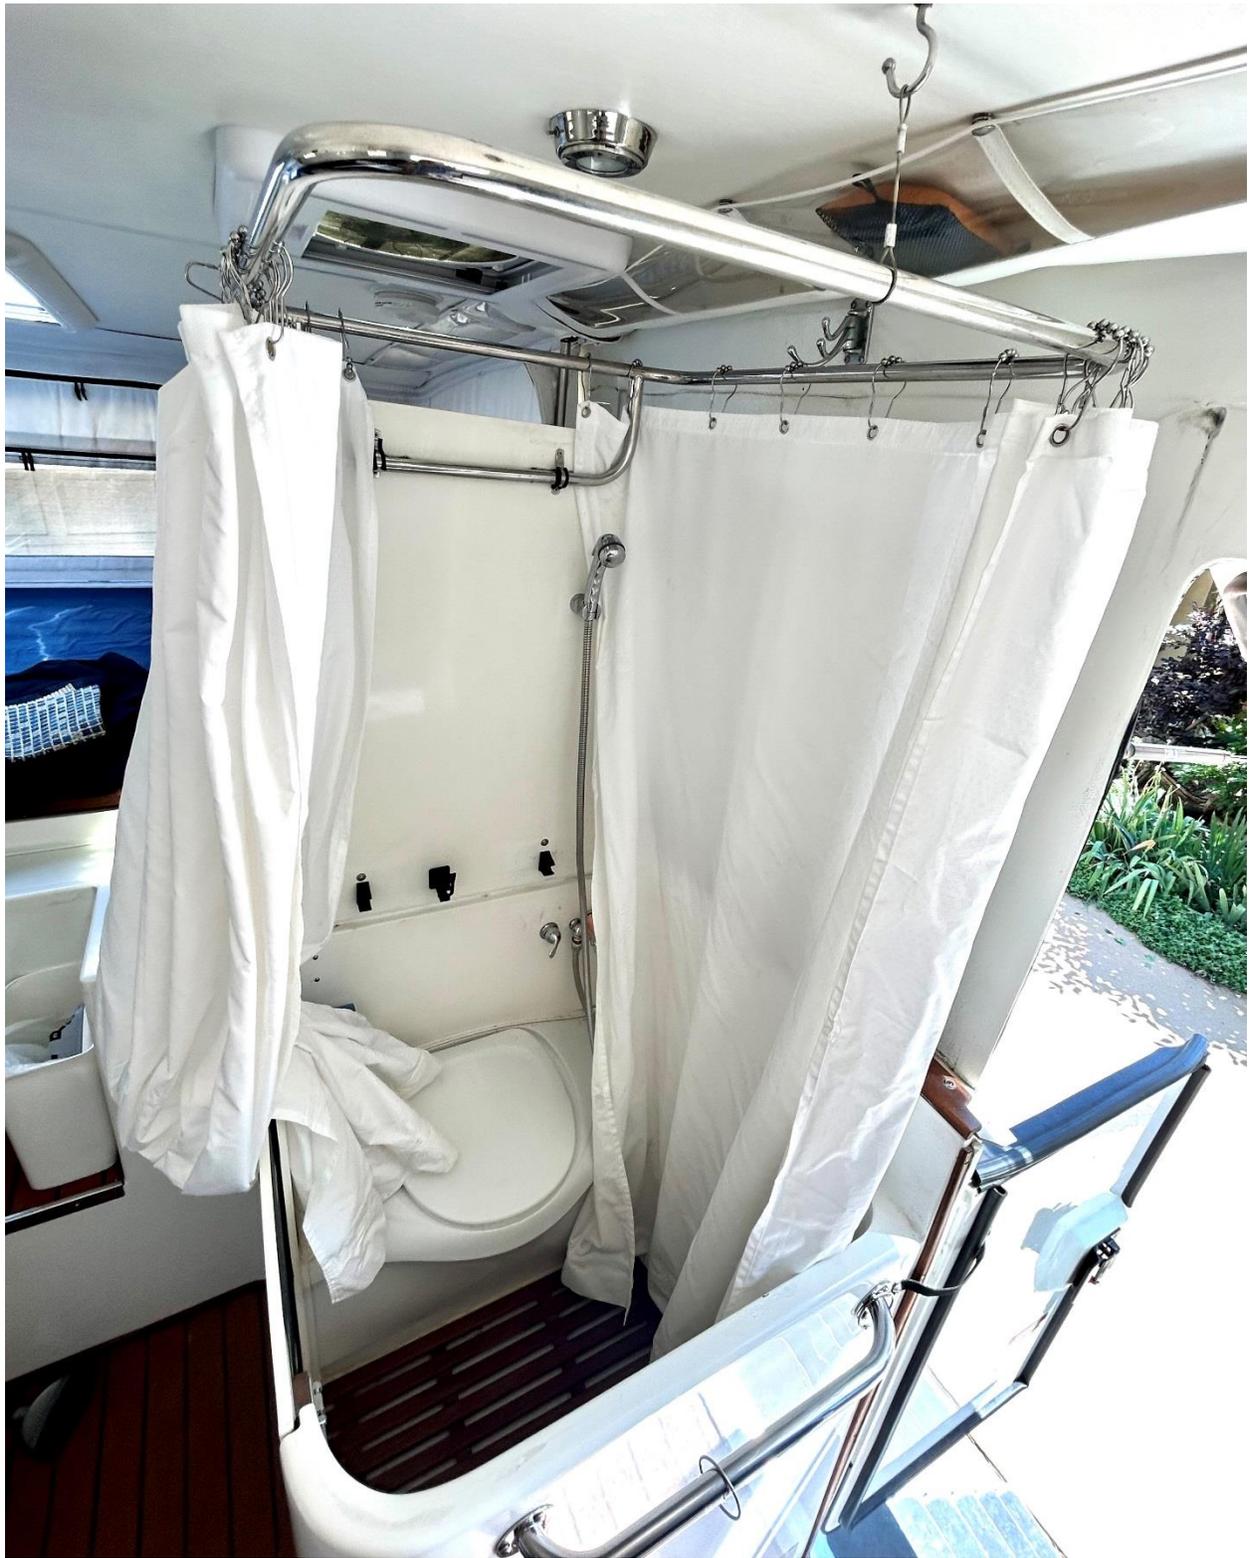
Figure 17: Wet Bath Opened

- 72 gallon (270 l) heated fresh water tank with vented external fill port
- 27 gallon (102 l) grey water tank
- Inside Wet bath: Shower / Thetford Cassette toilet C402. The wet bath has a lift up lid which deploys the shower curtain. When the bath/toilet is not in use the top stays down and offers additional counter/work space

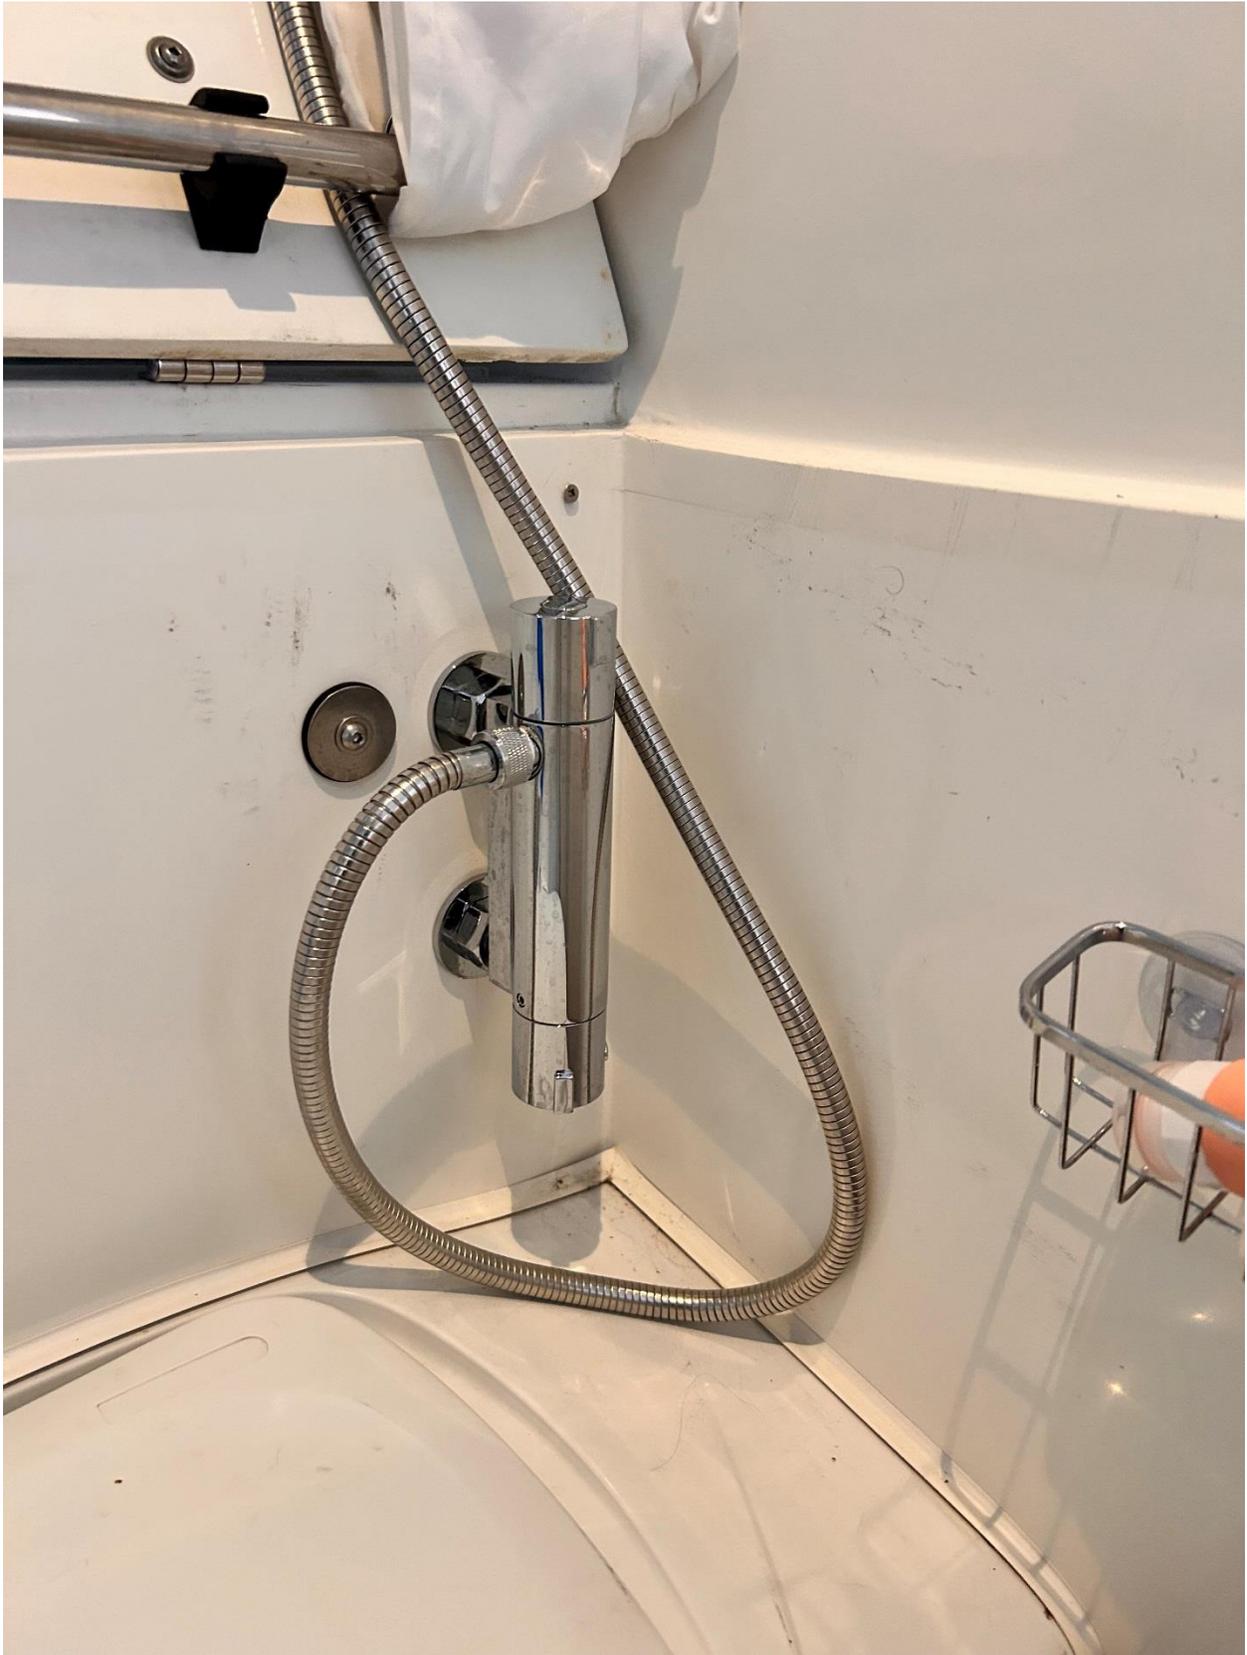
Figure 15: Thermostatic Shower Valve

- UV Water purification system controlled by switch in cabin. UV bulb replaced in 2023
- New macerator pump in 2023 to drain gray tank
- New Thermostatic shower valve installed in 2023 to replace original valve. This ensures an even temperature shower when the water pump cycles on/off
- IRVWPC installed in 2023 to smooth out water pump cycling and ensure smooth flow
